LOUISIANA DEPARTMENT OF WILDLIFE & FISHERIES

WATERBODY MANAGEMENT PLAN SERIES

LAKE LOUIS

LAKE HISTORY & MANAGEMENT ISSUES

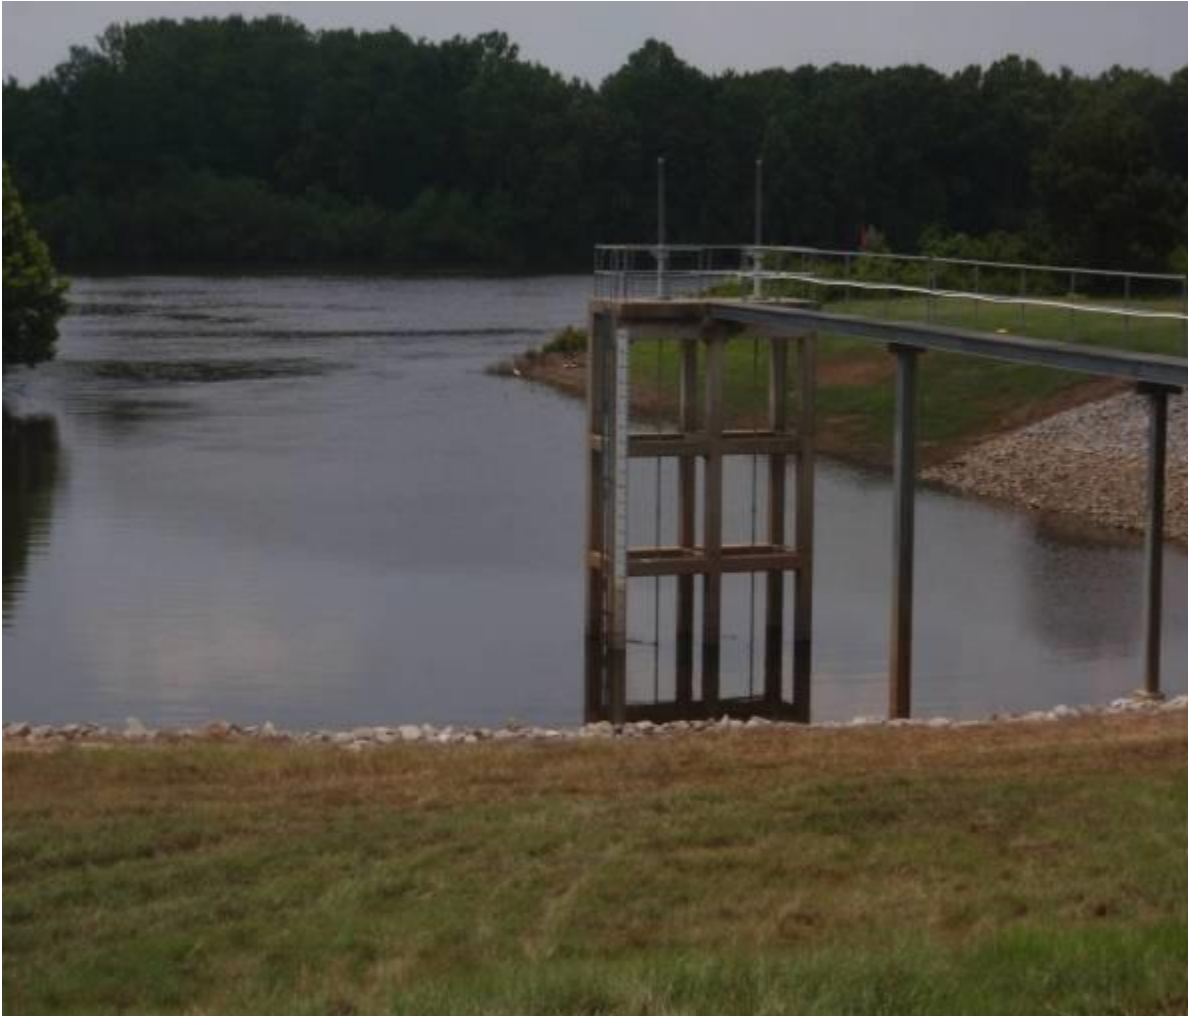
Appendix II
([return to drawdown](#))

Lake Louis drawdown structure

Drawdown structure- (sluiceway) -Photograph available in [Appendix II](#).

Gate size – 60” corrugated metal pipe (CMP) with vertical lift gates

Number of gates - 2

Condition – Good

Flow rate – 350 cubic feet per second (cfs)

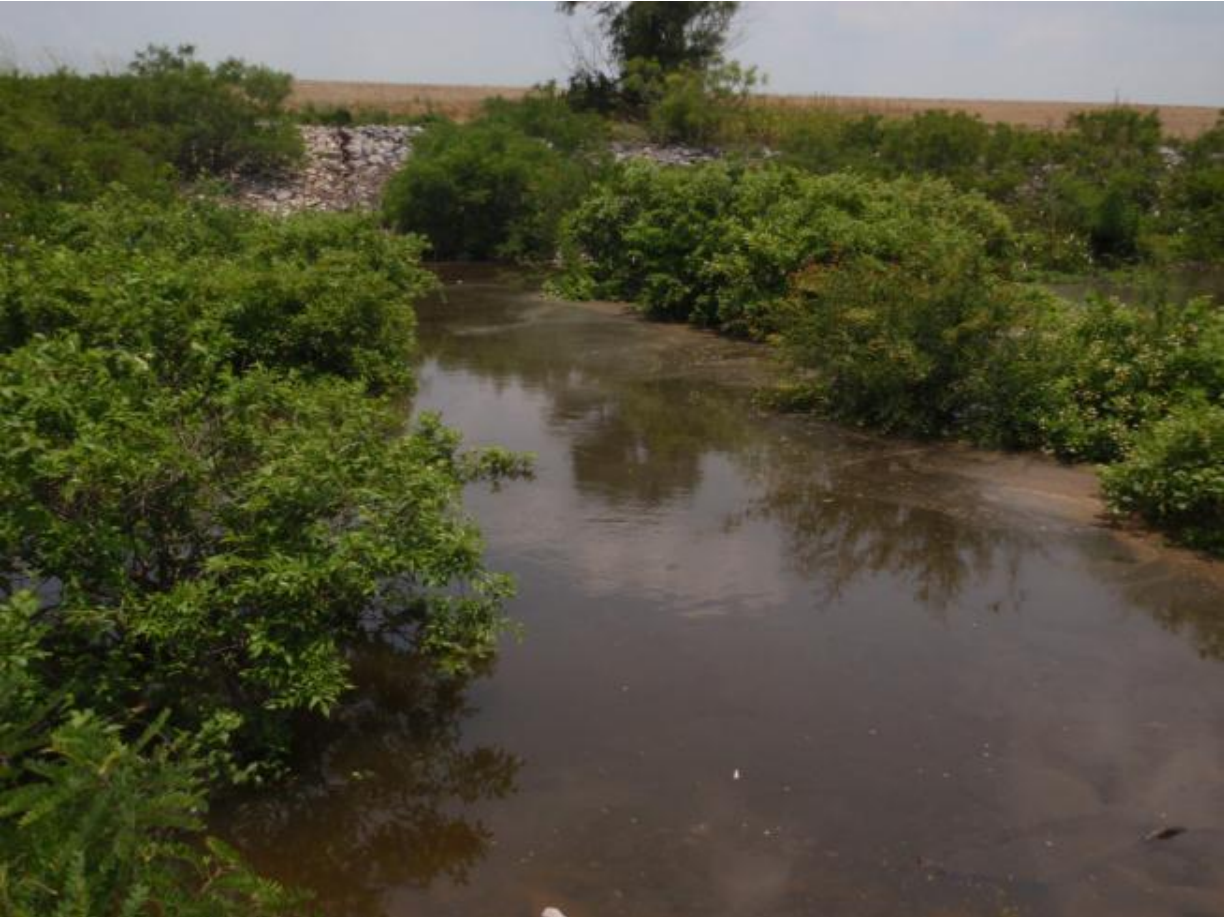
Appendix III
([return to spillway](#))

Lake Louis sheet piling/rock weir

Spillway – Photograph available in [Appendix III](#)

There is no spillway located at the drawdown structure. There is an un-gated sheet piling/rock weir approximately 100’ wide located in a man-made canal between Lake Louis and the Ha Ha Bayou pumping station. This weir maintains the 38.0 ft. MSL water level in Lake Louis and allows excess water to overflow to the Ha Ha Bayou pumping station.
